Finn Brook Crossing #3792 at Vigue Road

Sample Supplemental Documents

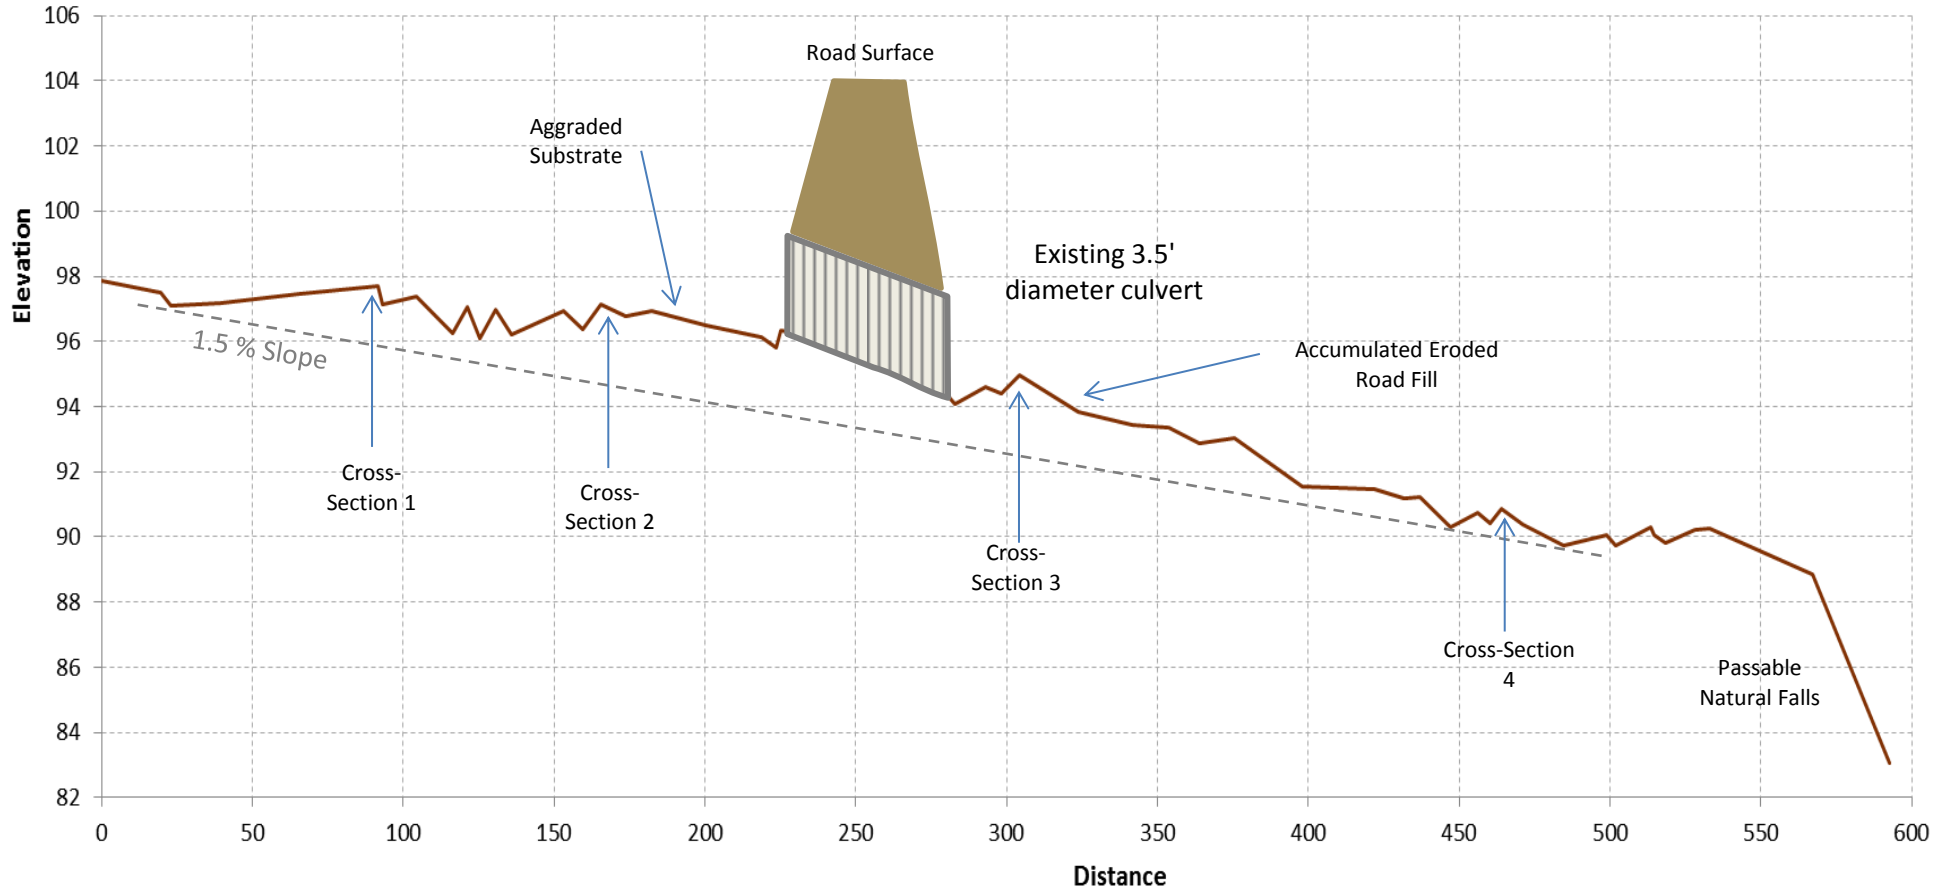
Longitudinal Profile - Existing Conditions

Existing slope and scour depths controlled by undersized road crossing frequently restricting flow and causing aggradation of stream substrate and eroded road fill. This view is vertically exaggerated, reflecting the different scales of units for elevation and distance.

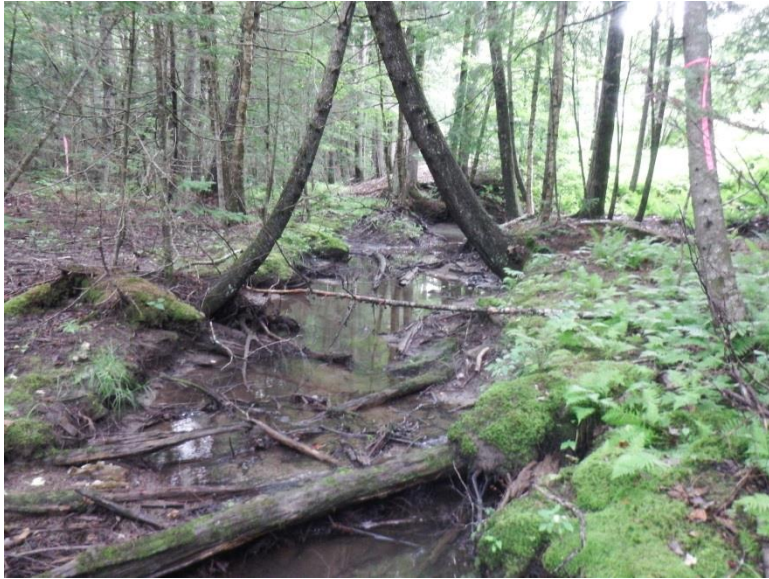
Upstream from Cross-Section 1

Cross-Section 1 - Reference Reach Upstream of Crossing

Note: This reach is very flat, and stream form is affected by woody material.

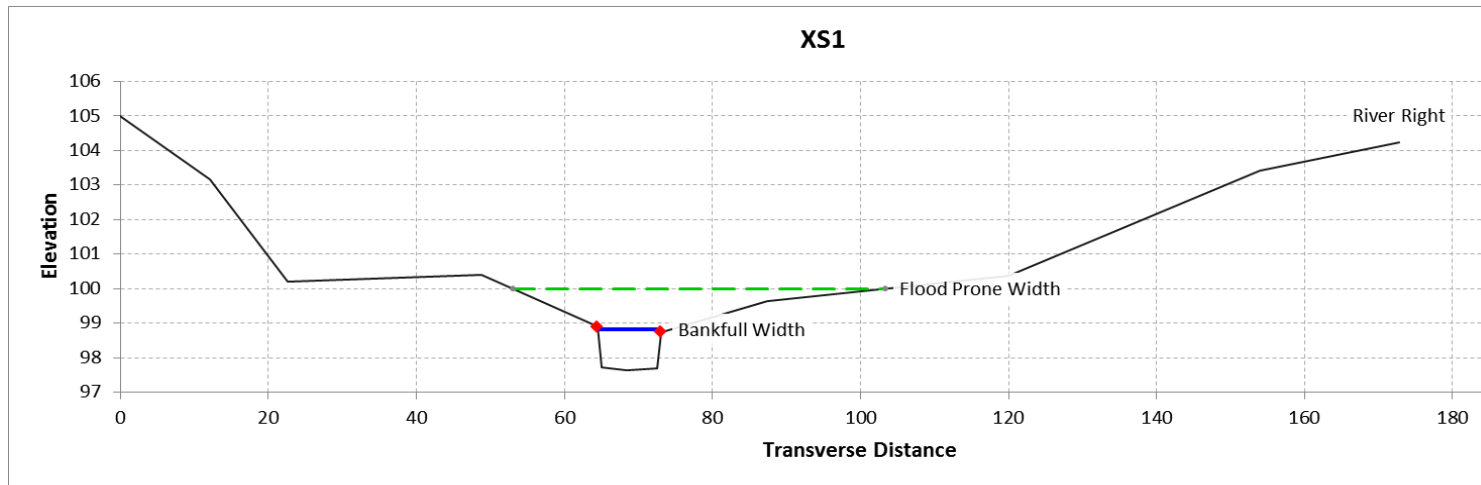
Bankfull Width:	8.58
Bankfull Depth:	1.17
Bankfull XS Area:	9.11
Bankfull Wetted Perimeter:	9.92
Bankfull Hydraulic Radius:	0.92
Bankfull Hydraulic Depth:	1.06
Bankfull Width:Depth Ratio:	7.3
Entrenchment Ratio:	5.9

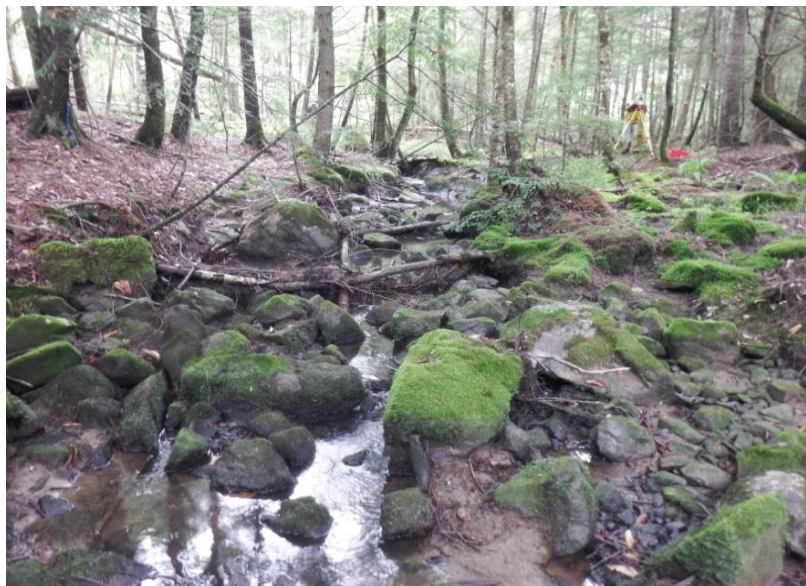
Upstream from Cross-Section 2

Cross-Section 2 - Reference Reach Upstream of Crossing

Note: This reach is very short and relatively steep, composed of cobble and small boulders, and is similar to the top of the downstream natural falls.

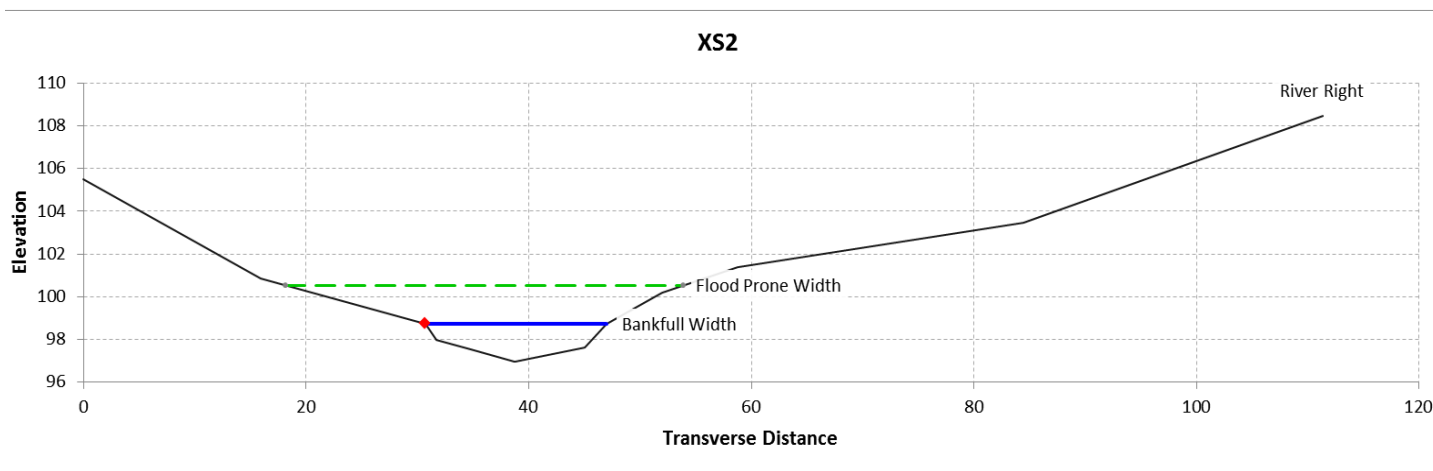
Bankfull Width:	16.29
Bankfull Depth:	1.79
Bankfull XS Area:	19.61
Bankfull Wetted Perimeter:	16.96
Bankfull Hydraulic Radius:	1.16
Bankfull Hydraulic Depth:	1.2
Bankfull Width:Depth Ratio:	9.1
Entrenchment Ratio:	2.2

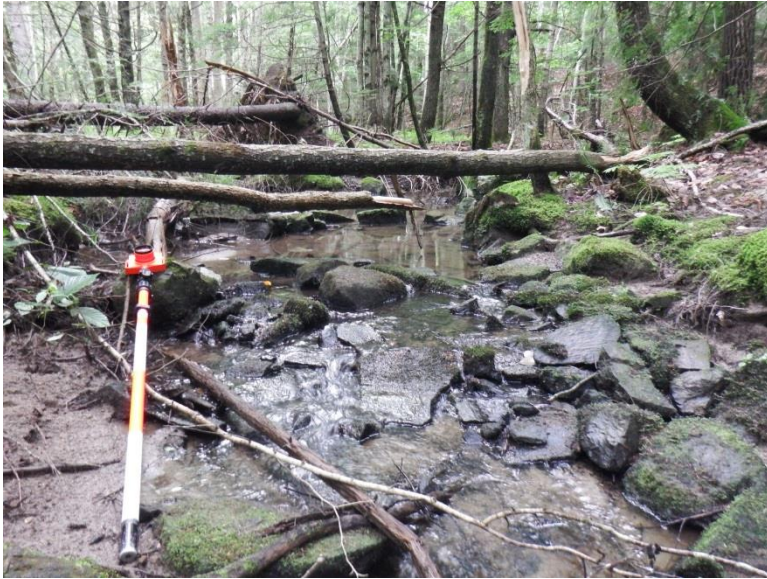
Upstream from Cross-Section 4

Cross-Section 4 - Reference Reach Downstream of Crossing

Note: This reach is very short and of similar slope to the overall reach, composed of cobble and sand, and appears to represent the most suitable reference reach on which to base design of the replacement crossing.

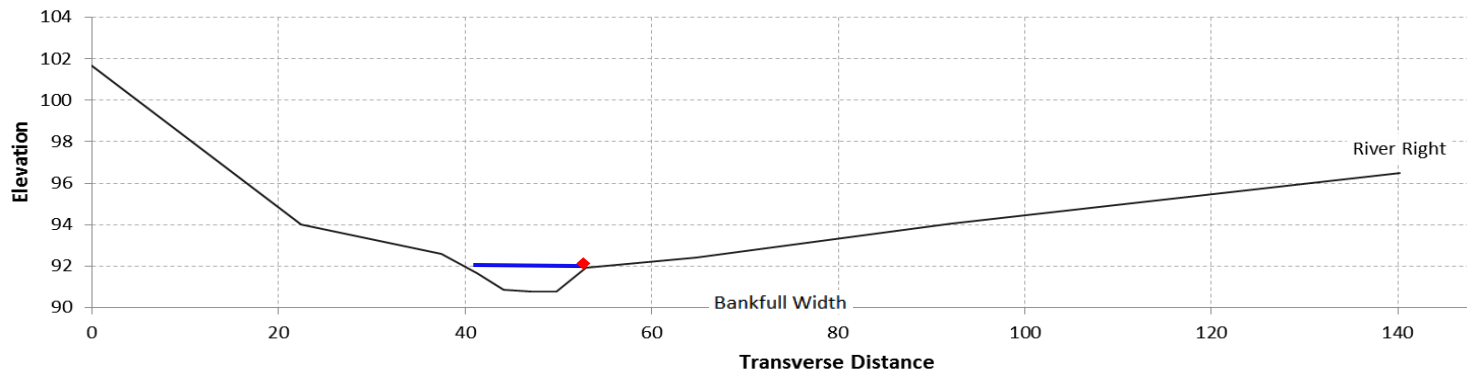
XS4

Bankfull Width: 12
 Bankfull Depth: 1.14
 Bankfull XS Area: 12.5

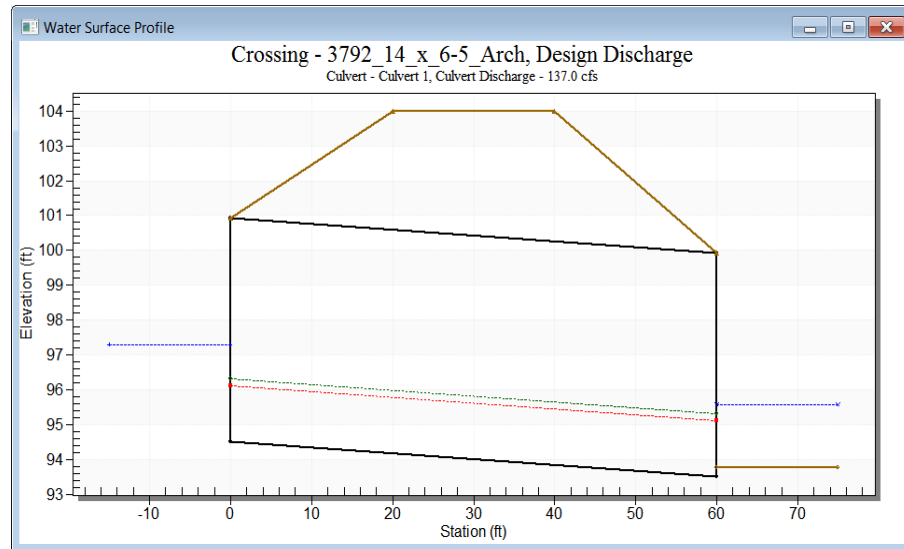
HY-8 Hydraulic Analysis Program of the U.S. Federal Highway Administration provides results for the above peak flow estimates for the proposed arch design, and indicates that the crossing as proposed will easily pass the expected 100-year (and 500-year) storm events.

Discharge Names	Total Discharge	Culvert Discharge	leadwate Elevation (ft)	Inlet Control Denth(ft)	Outlet Control Denth(ft)	Flow Type	Outlet Depth (ft)	Outlet Velocity (ft/s)
1 year	19.00	19.00	95.33	0.59	0.83	3-M1t	1.43	1.12
2 year	39.00	39.00	95.81	1.15	1.31	3-M1t	1.62	2.04
5 year	61.00	61.00	96.26	1.62	1.76	3-M1t	1.76	2.95
10 year	77.00	77.00	96.55	1.89	2.05	3-M1t	1.83	3.57
25 year	100.00	100.00	96.94	2.24	2.44	3-M1t	1.93	4.41
50 year	117.00	117.00	97.20	2.49	2.70	3-M1t	1.99	5.00
100 year	137.00	137.00	97.28	2.78~	0.00	3-M1t	2.06	5.67
500 year	184.00	184.00	98.20	3.41	3.70	3-M2t	2.19	7.17

Note that prediction errors are quite large when using regression equations to estimate flows and bankfull widths based on drainage area. It is best to account for potentially larger flows at these return intervals.
