MISHAP INVESTIGATION REPORT

STARSHIP ORBITAL FLIGHT 1
EXECUTIVE SUMMARY

SEPTEMBER 8, 2023

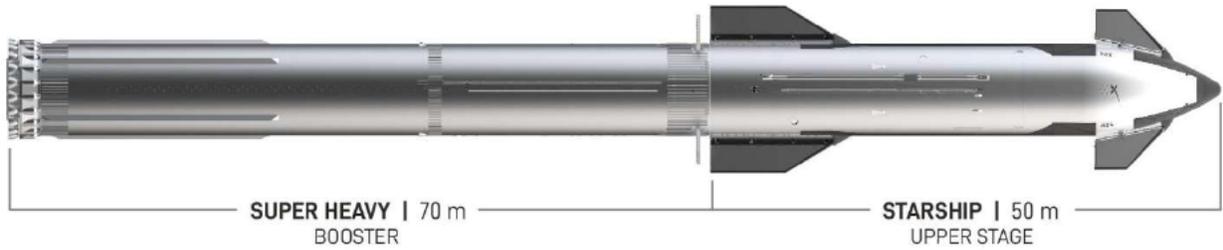
Figure 1: Starship-Super Heavy vehicle overview

SpaceX built the OTF-1 Starship and Super Heavy vehicles at the Starbase production facility in Boca Chica, TX. The Starship-Super Heavy orbital launch system is comprised of two stages: the Super Heavy Booster and Starship. For OTF-1, the vehicles were Super Heavy Booster 7 (known also as simply “Booster 7” or “B7”) and Starship 24 (known as “Ship 24” or “S24”). Booster is designed with a main liquid oxygen (LOx) tank, a main liquid methane (LCH4) tank, a liquid oxygen landing tank, thirty-three Raptor sea-level engines, grid fins, sub-assemblies, and a flight termination system. Ship is comprised of a LOx tank and header tank, a LCH4 tank and header tank, an aft skirt, three Raptor sea-level engines, three Raptor vacuum engines, a nosecone, flaps, sub-assemblies, and a flight termination system. An overview diagram is shown in Figure 1.
