From: [BrownScott, Jennifer](#)
To: [Ralph Riccio](#)
Subject: Fwd: Eelgrass Survey maps
Date: Monday, September 26, 2016 1:10:46 PM
Attachments: [DNGtidelandPresAbsen Eelgrass9.26.16.pdf](#)
[DNGtidelandPresAbsen Eelgrasswtracklogs.pdf](#)
Importance: High

From: **Sollmann, Lorenz** <lorenz_sollmann@fws.gov>
Date: Mon, Sep 26, 2016 at 12:47 PM
Subject: Eelgrass Survey maps
To: Jennifer BrownScott <jennifer_brownscott@fws.gov>

Presence Absence Eelgrass Survey

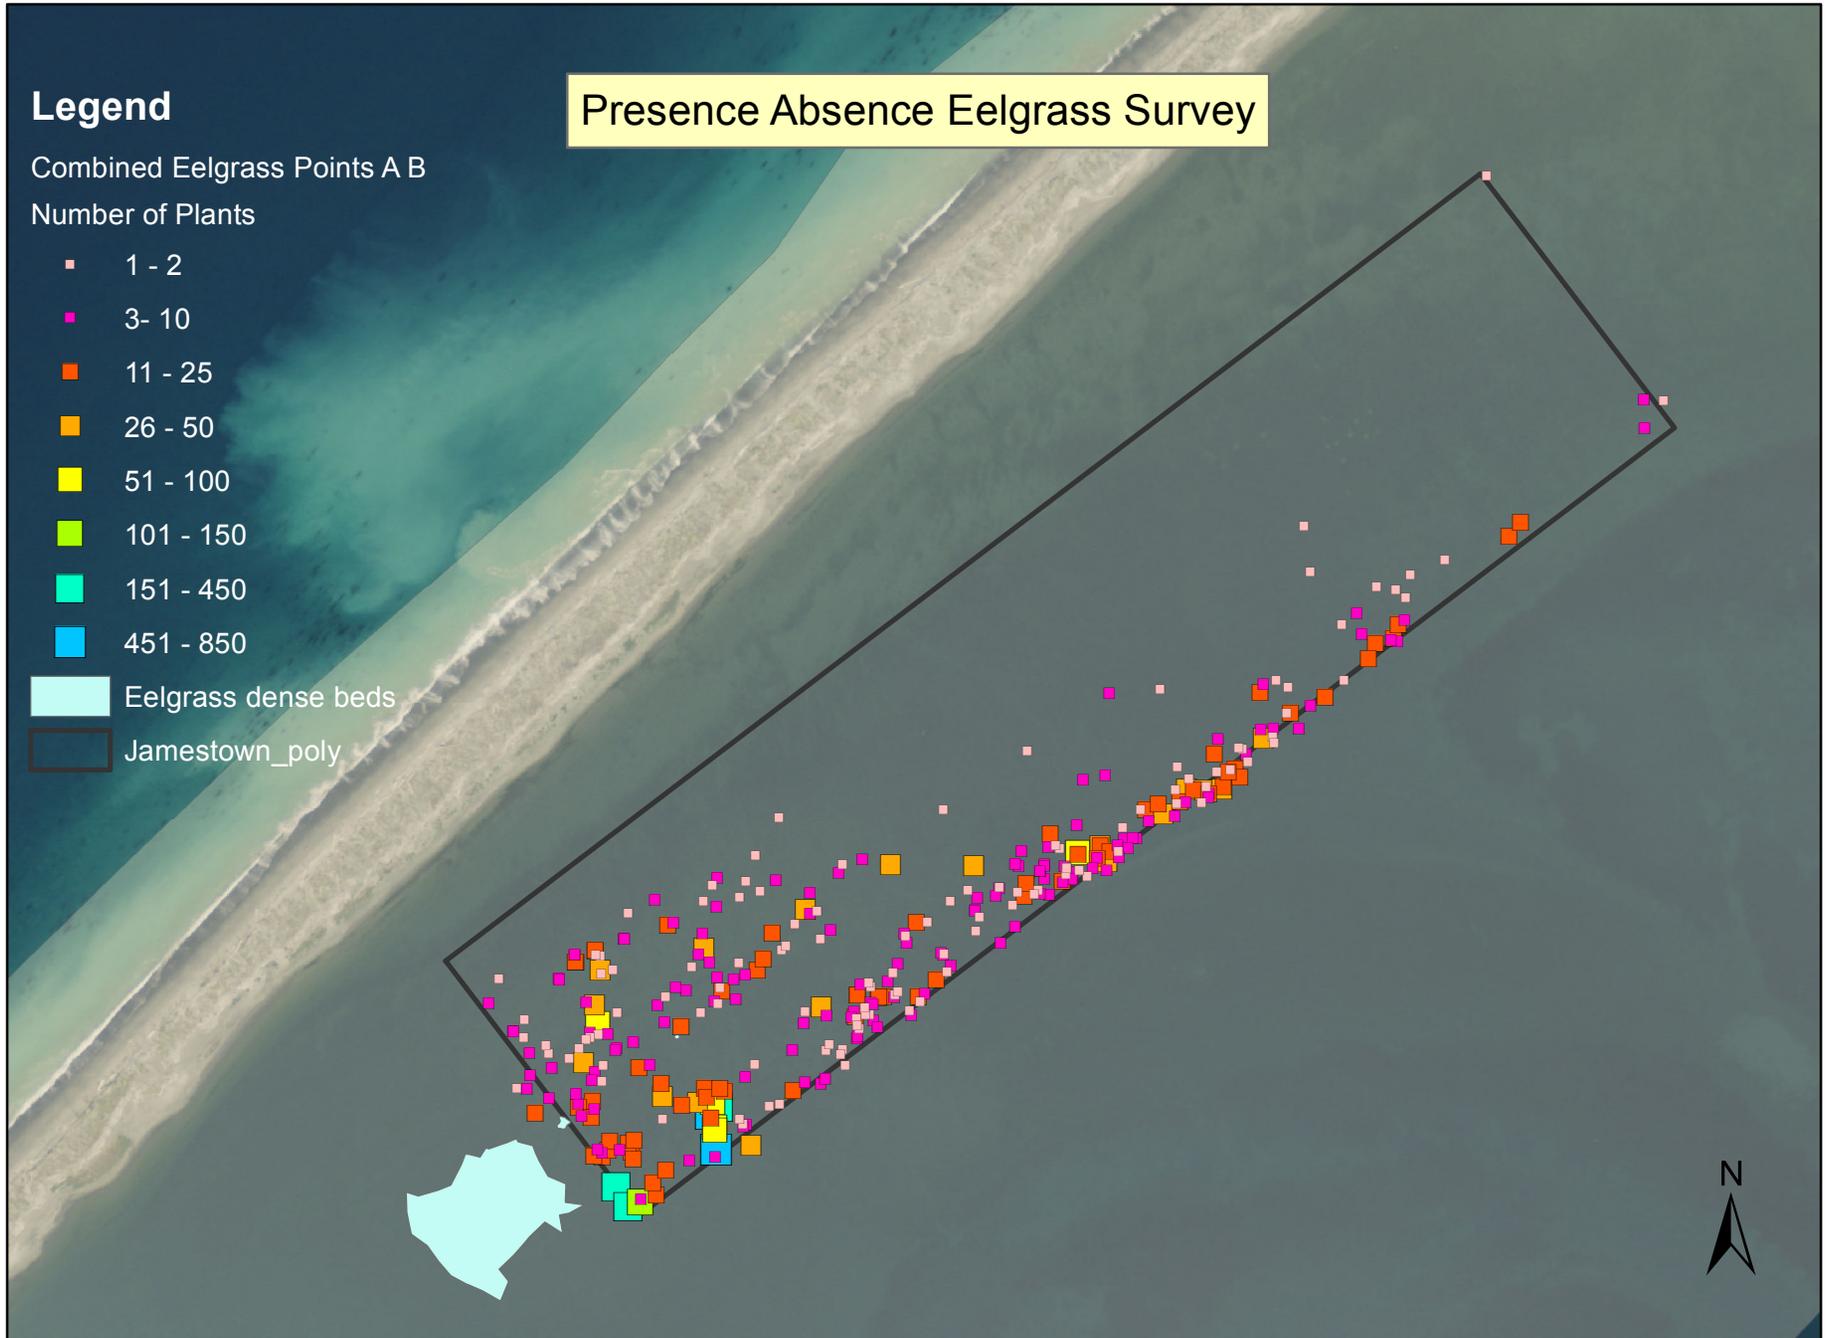
Here are the 2 maps, one with the track logs displayed the other without for a cleaner copy. Some comments about the maps:

- The 7/1 track line was from Ralph's GPS unit.
- The breakdown for the number of plants was to separate out the 1-2 just as hits for presence, but that the 3 and up would indicate the location of what our understanding of the ACOE definition considers as a stand alone bed.

- A number of points were collected on both days with the same information. Ones that were obviously duplicates were removed.

There certainly are many points very close to each other that could have been captured as a polygon during the survey. We were not making any determination if some of these points separated by less than a meter or so should be collected in a different way. If nothing else, the

survey does inform us that when oyster production was active and there was no eelgrass stated to be present, that in the intervening closed years the eelgrass has come back.

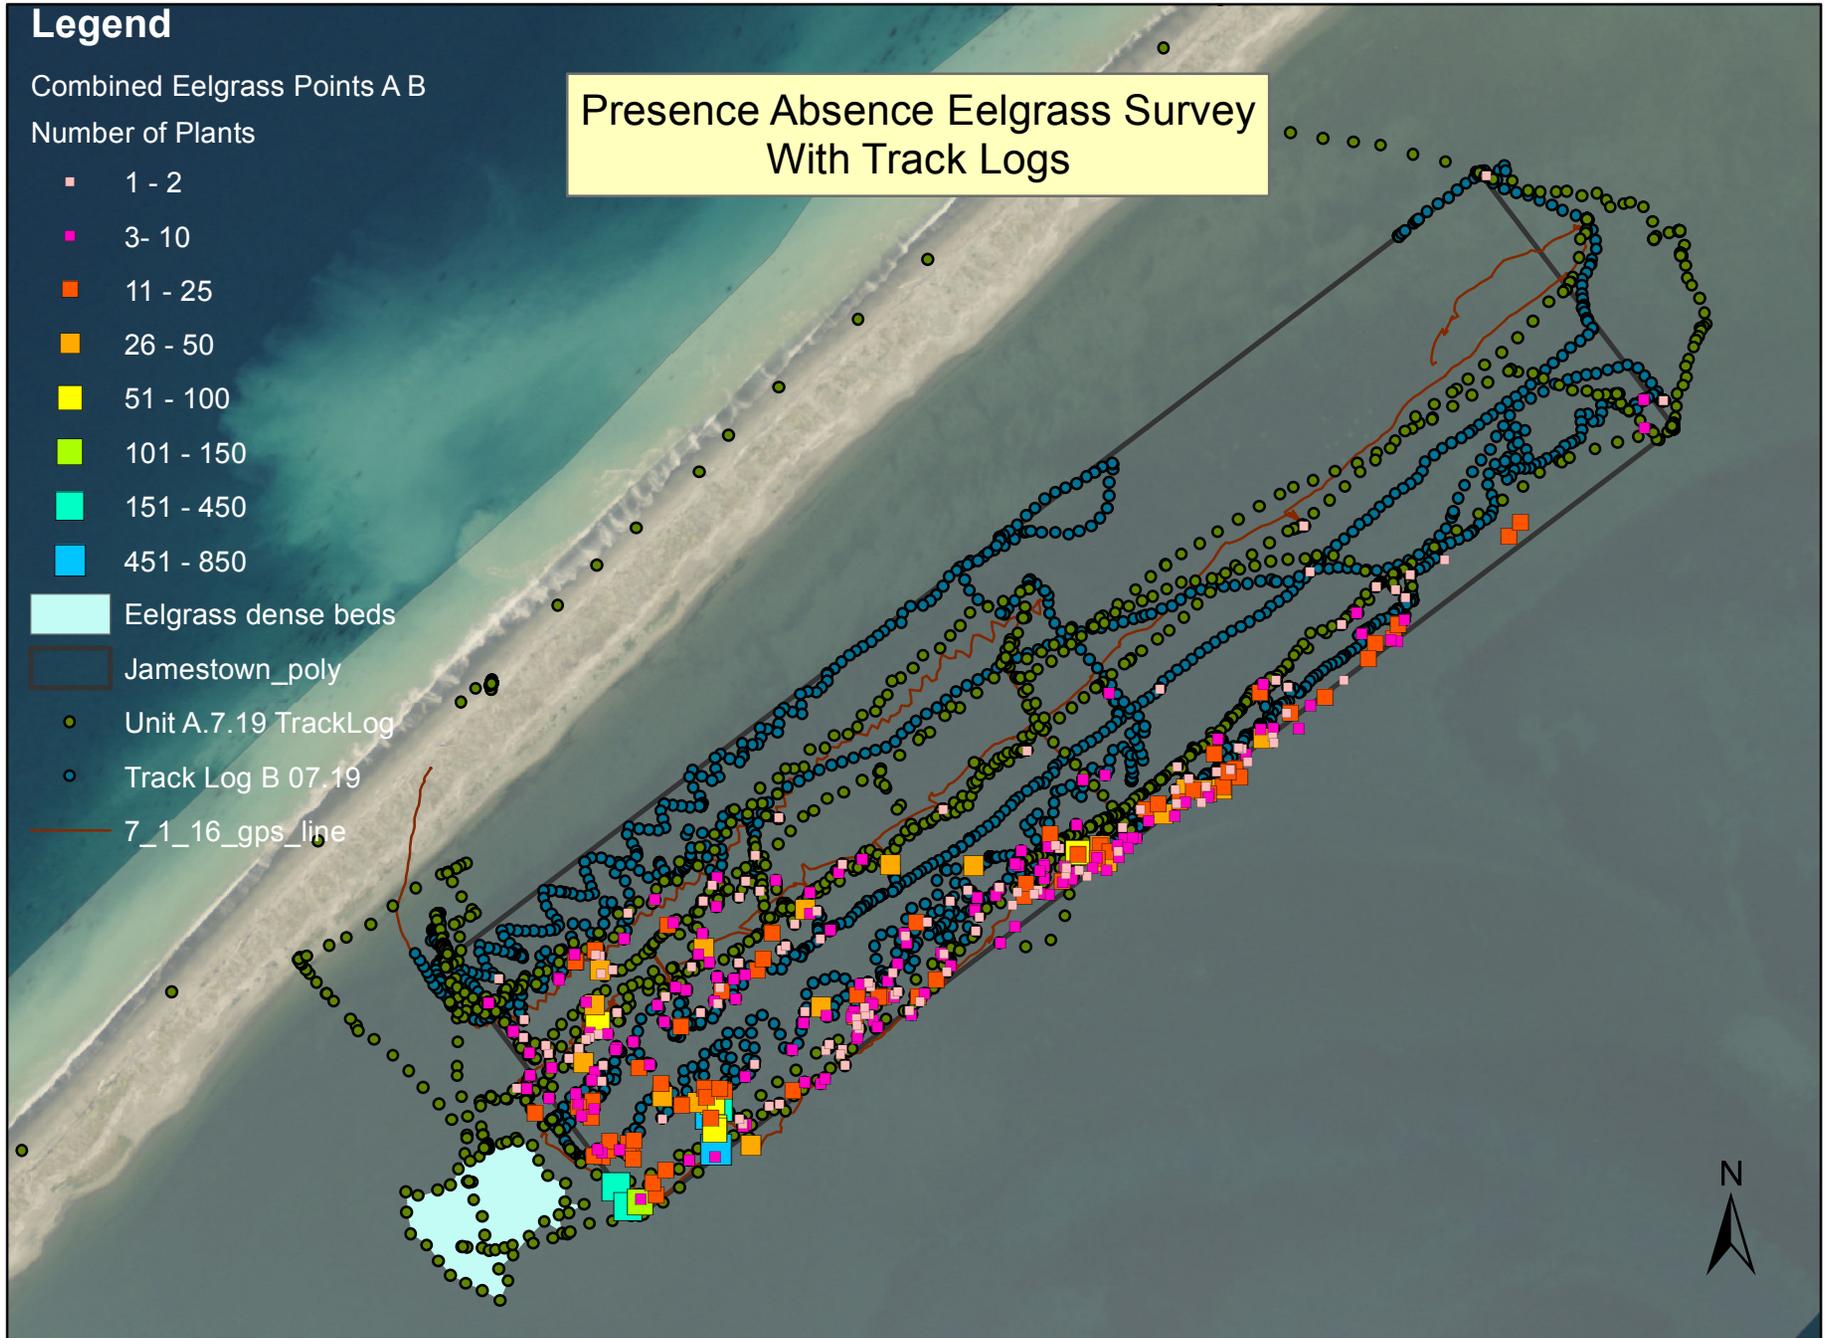
Presence Absence Eelgrass Survey With Track Logs

- There are 2 track logs displayed, one from each survey date (7/1, 7/19). The 2 units were combined by date.
- There was a short glitch with capturing the track log on 7/1. The NE quarter the blank area along the boundary was actually walked. Also, in the same NE quarter there is a big empty area with no eelgrass or track log date. This area was walked by volunteers or staff without a GPS unit. These observers were walking between observers caring the GPS units. Additionally this area appeared to be the highest in elevation, therefore, the most time out of the water, and where a harder substrate exists with shell fragments.
